# Newman Building Solutions Limited

## Balcony Repairs—Old Fire Station Hammersmith

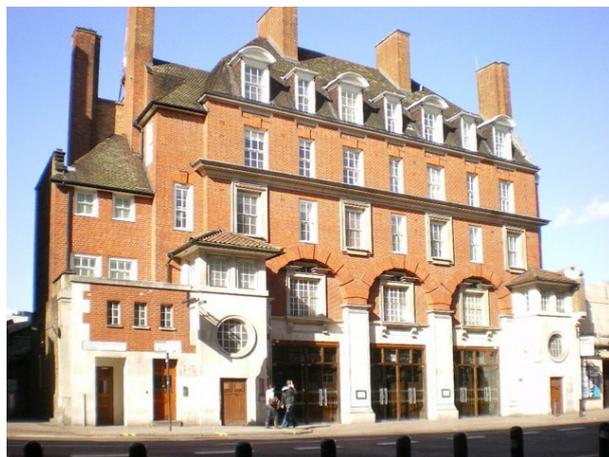
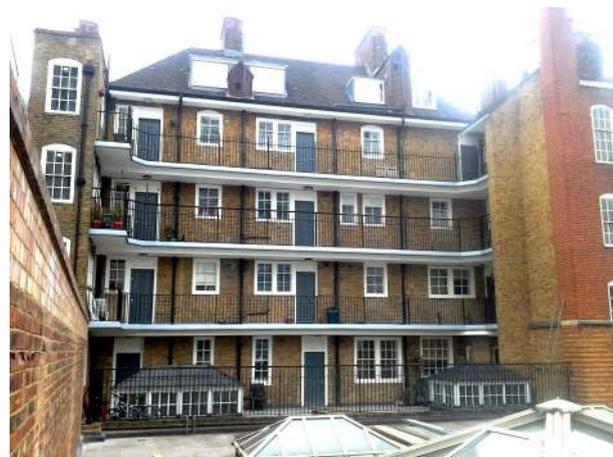
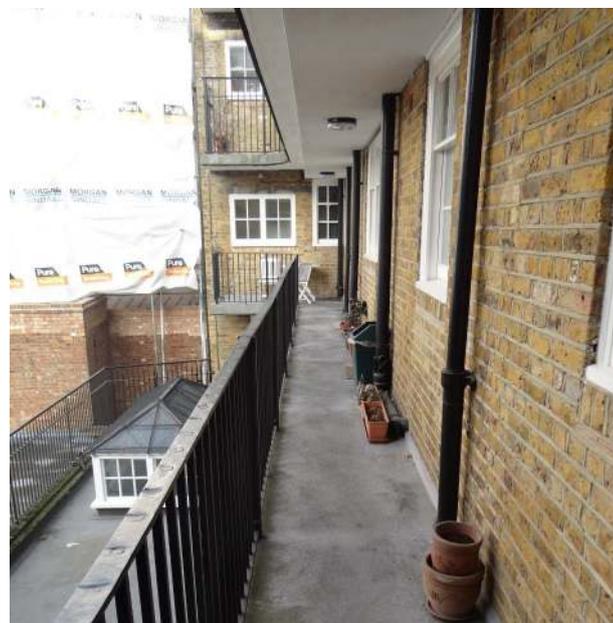
The concrete balconies had suffered cracks and corrosion caused by water ingress and carbonation and had lost their structural integrity.

The concrete undersides, front edges and top sides of all three balconies were hammer tested and all loose and defective concrete removed. Any exposed steel reinforcing rods that were corroded were cleaned to sound steel using mechanical abrasion and all areas of the balconies were grit blasted using our Safe Blast system to remove any existing coats of paint, failed balcony covering and all evidence of rust from exposed steel.

All exposed steel was then treated with Sika® 610 Cementitious Based Steel Reinforcement Primer and Bonding Bridge.

All cracks to the balcony topside were then cut out to at least 30mm either side of the existing crack. These were flushed with water and RPM Belgium ready rep asphalt repair mortar was applied.

Sika® MonoTop-615, a cement based polymer modified high build repair & reprofiling mortar and Sika® Rapid Repair Mortar a fast setting cementitious repair mortar, were applied to all exposed areas requiring repair. Due to the depth of the required repair this was done in layers ensuring the mortar was well compacted and bag rubbed to gain a high bond with the existing concrete. Due to the complicated profile this required high degrees of skill.

Sika® MonoTop-620 a cementitious polymer modified mortar was then applied in a 2mm layer ensuring a smooth and flush finish.

The balcony topside, up-stands and front edge were pressure washed to remove all dust grease and dirt.

A minimum of 3 coats of RPM Belgium Vulkem Waterproof anti-slip walkway coating was then applied to the balcony topside, up-stands and front edge. This was followed by a thick layer of anti-slip sand and seal.

Pure brilliant white Flexcrete Monodex Ultra Series 2 Anti-carbonation coating was applied to the balcony underside and concrete front edge. This is a high performance specialist coating that resists carbonation and allows any trapped moisture to escape through the coating without bubbling or peeling.

Balcony undersides were also repaired and decorated.
